Visual Termite Inspection & Report in Accordance with AS 3660.2-2000

XXXXXXXX, Wyee New South Wales, 2259 Australia

Visual Termite Inspection Report in accordance with AS 3660.2-2000

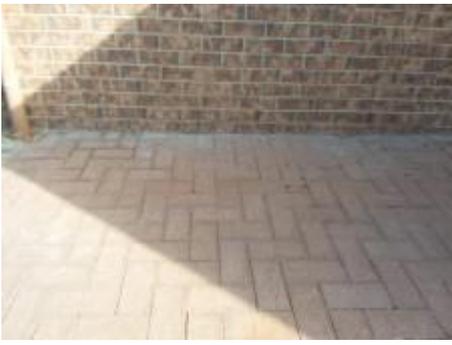
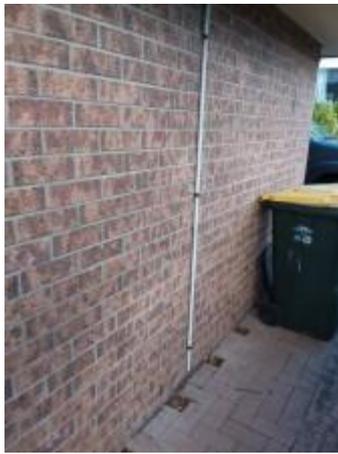
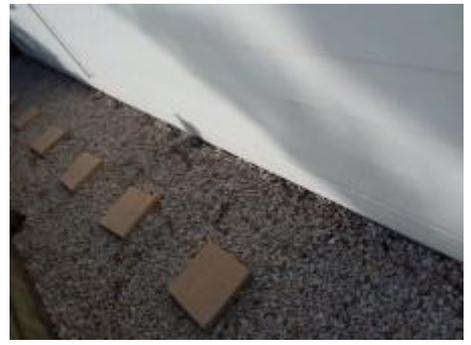
Slab Edge cover in certain areas to main house

Does the slab edge inspection zone fully comply?	No, arrange for slab edge to be exposed
---	--

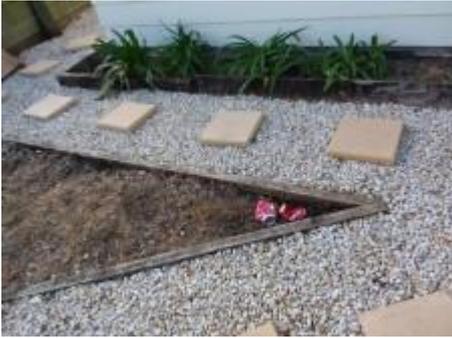
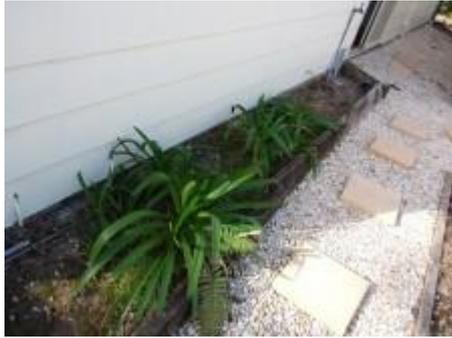
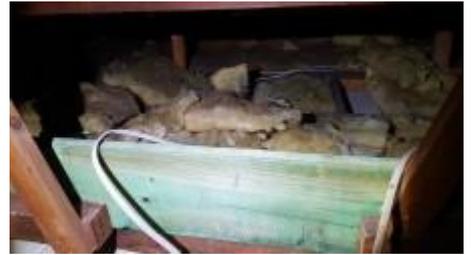
Slab edge covered to granny flat

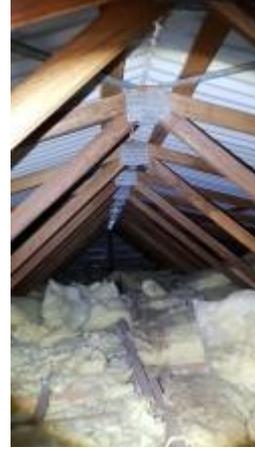
Roof void to main house with insulation

Where insulation is present in the roof void it is recommended it be moved or removed and an inspection be carried out to the wall top plate timbers and other roofing timbers covered by the insulation. This invasive inspection will not be performed unless a separate contract is entered into.

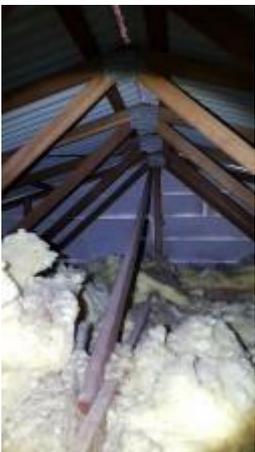
Roof void to granny flat

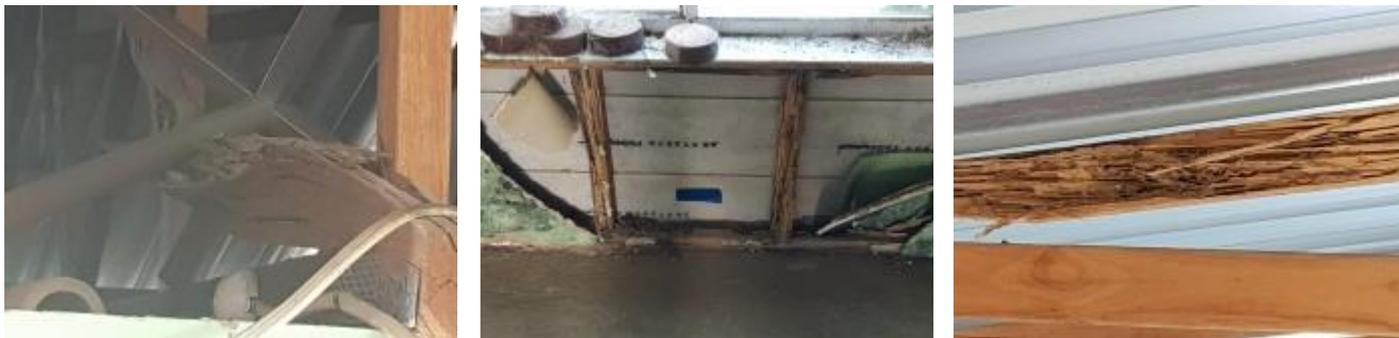
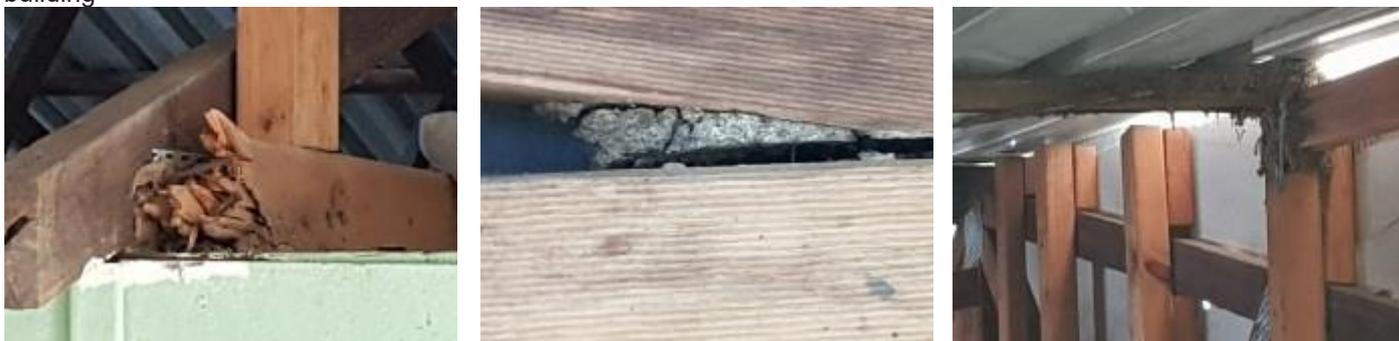
Extensive structural damage 2 old shed building

Environmental, other Conditions and/or general information: The old shed appears to be structurally damaged and is a OH&S issue. We recommend a structural engineer to assess the Integrity of this building further

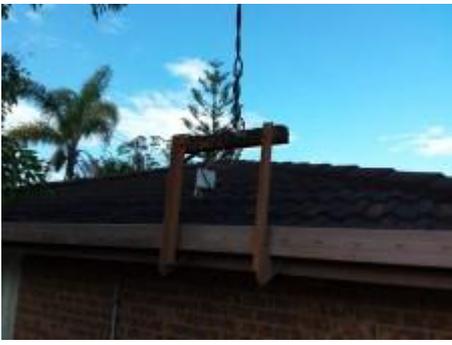
Severe wood rot to electric entry point to main house

Wood decay fungi are conducive to subterranean termites. You should consult a builder or other building expert to find out what must be carried out to prevent further decay (repairing of drainage, leaks and/or sealing the timber) and to repair the damage.

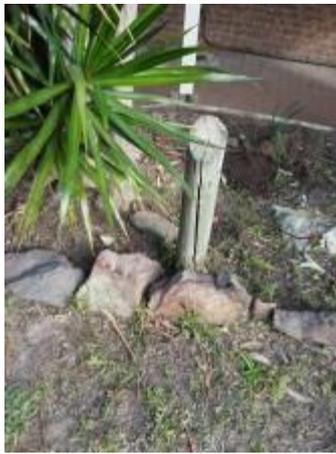
Weathering and slight wood rot to garden Timbers

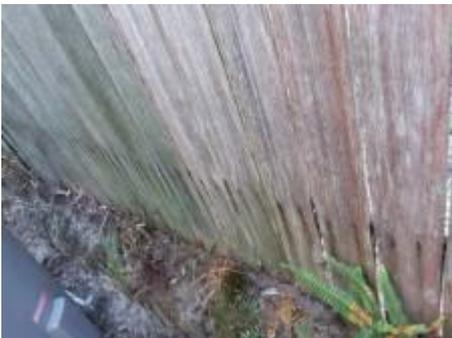
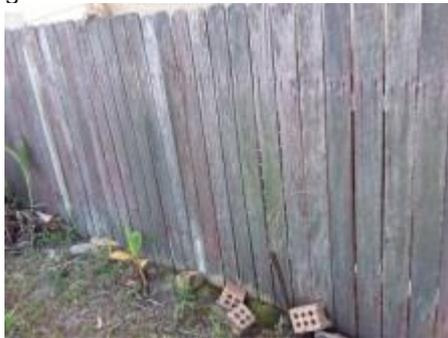
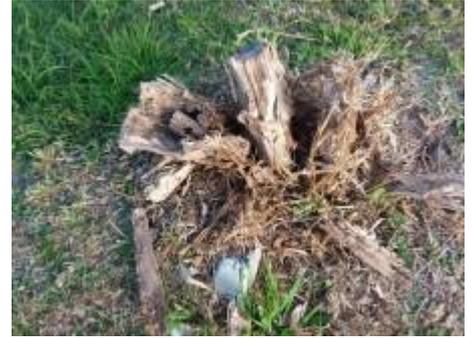
Wood rot to wooden fence line to left-hand side of property

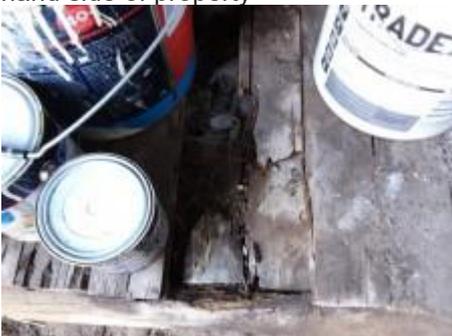
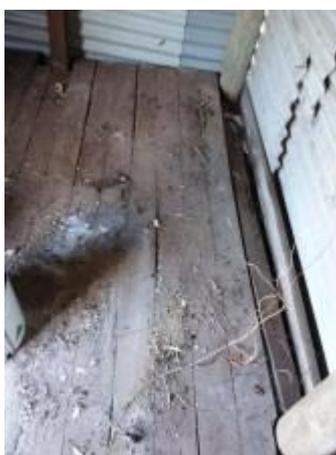
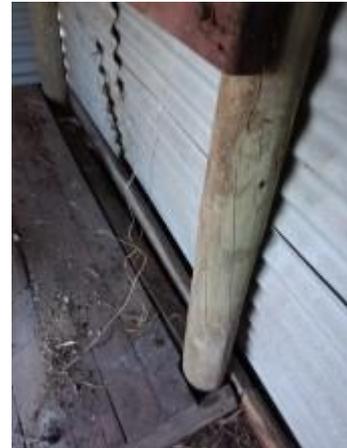
Wood rot to flooring in chicken shed

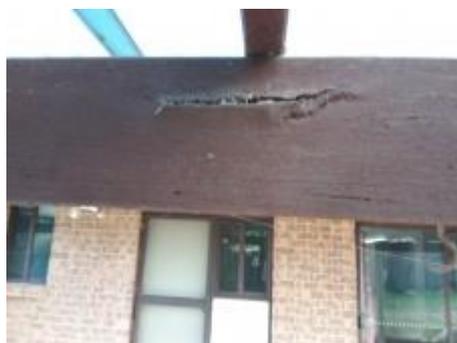
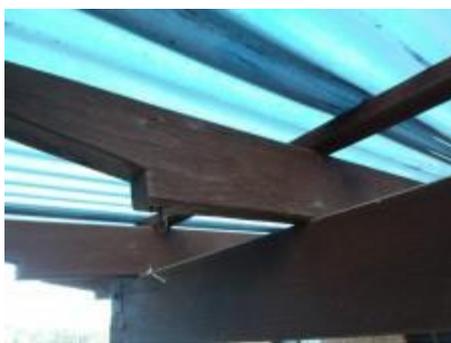
Slight wood rot to pergola covering rear patio

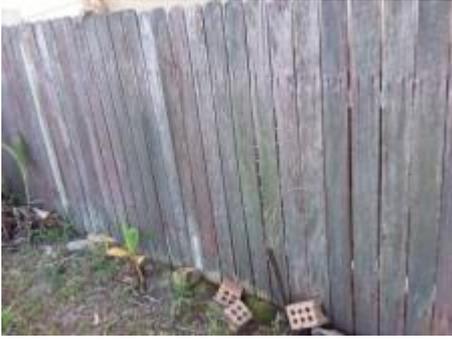
timber fence posts and fencing in direct contact with the ground and can attract termite activity

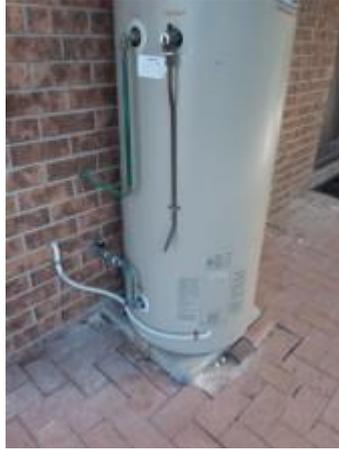
Hot water heater Overflow to the main house and the granny flat a dripping water to external walls this can attract termite activity due to moisture buildup recommend plumbing into drain

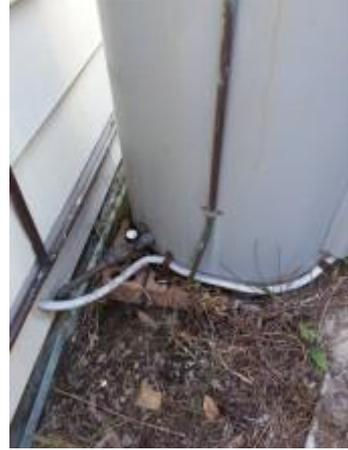
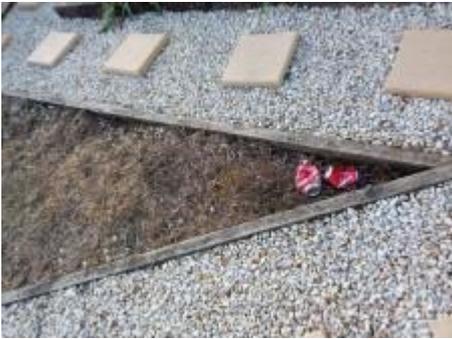
Garden Timbers are in direct contact with the ground and can attract termite activity

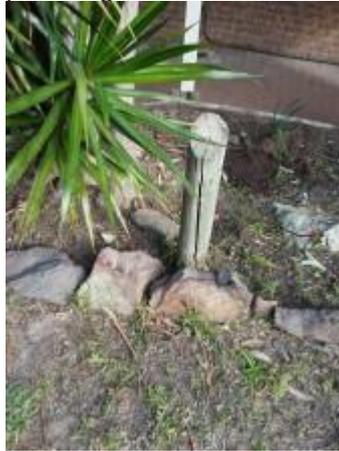
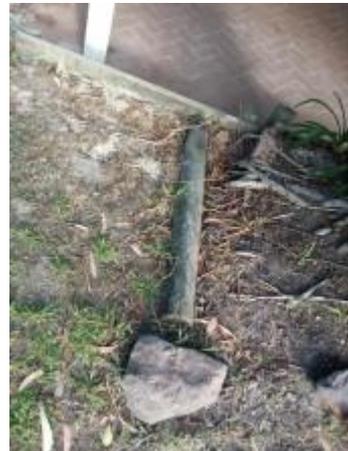
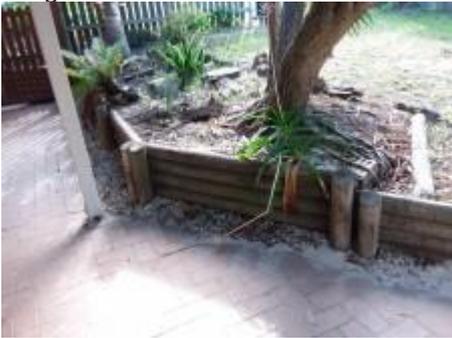
Wooden retaining walls are in direct contact with the ground and can hide termite activity to the property

Any Timber retaining walls should be replaced with non-susceptible material. You should consult a builder prior to removing/replacing retaining walls.

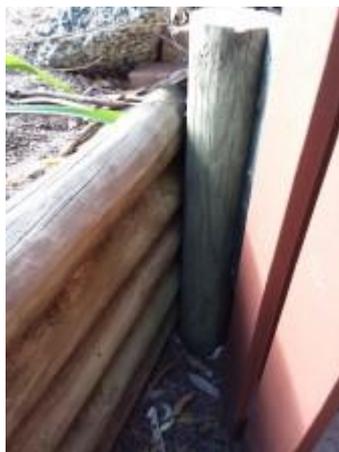
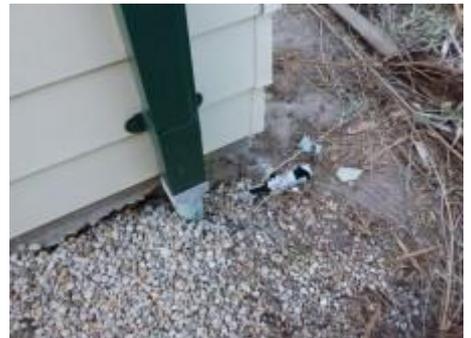
Whilst not a plumber, it appears that water leaks are	Present
Areas where leaks should be attended to by a plumber or other expert and why:	Downpipes to granny flat or damaged causing a moisture build up in the ground which can attract termite activity

Damaged down pipe drainage to granny flat

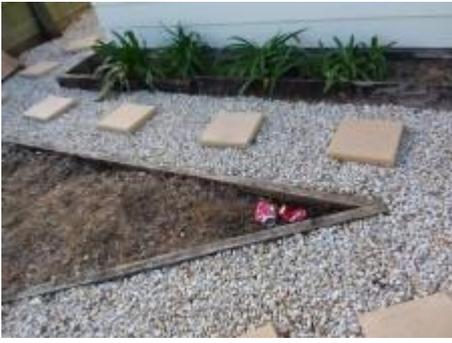
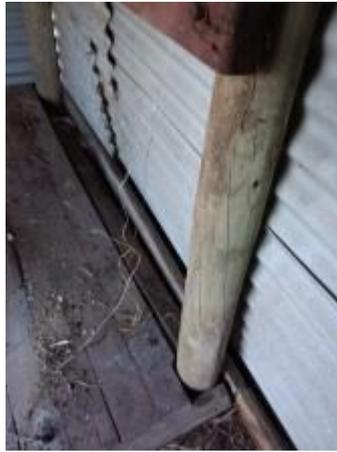
The chicken house structure is in direct contact with the ground and can attract termites

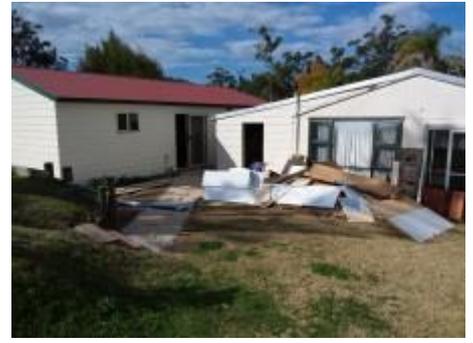
The old shed show signs of structural damage due to previous termite activity
